The Permanent Solution for Rotten Posts

Introducing the new PERMA-COLUMN • PC6600

POST REPLACEMENT step-by step guide

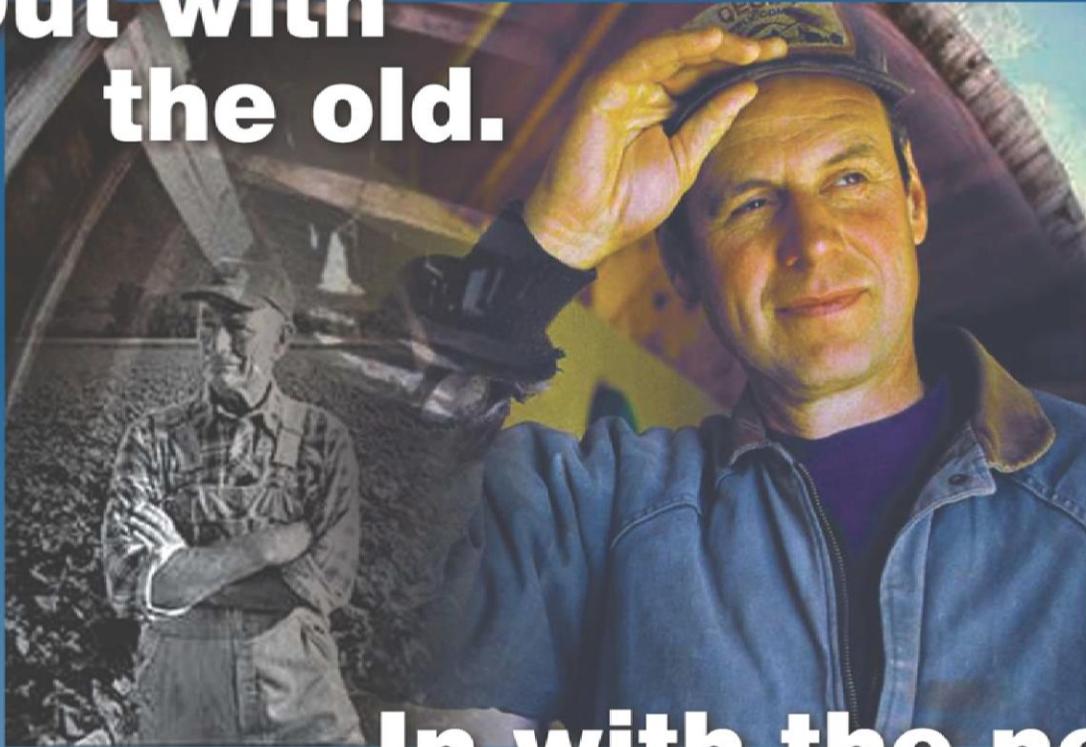
Out with the old.

In with the new!

The same pre-cast technology available in new construction can now be used to repair rotten posts. Don't let deteriorated posts compromise a building with many useful years left in it! The PC6600 is a long awaited answer to an old and ongoing problem.

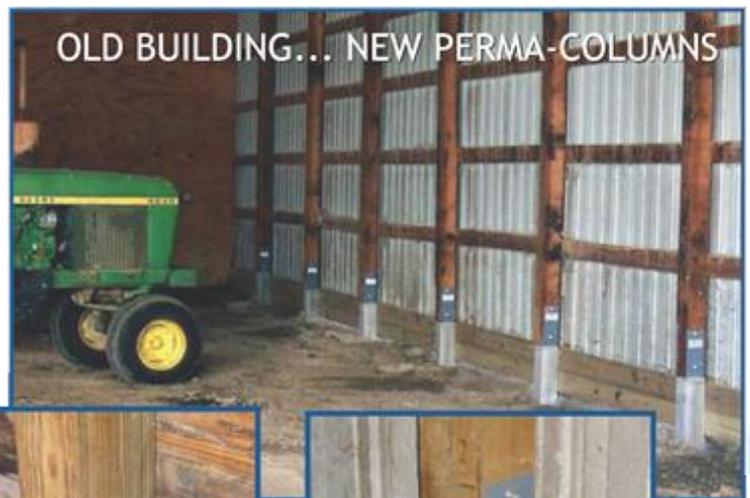
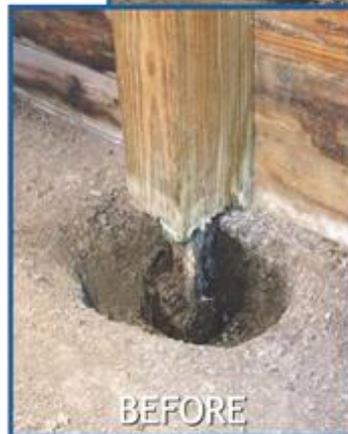
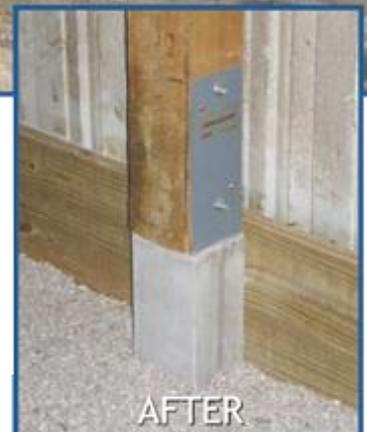
1. Locate rotten post to be replaced. Detach siding and remove existing skirt board.
2. Dig down next to face and sides of rotten post with auger.
3. Support truss with brace and hydraulic jack.
4. Cut rotten post off at ground level. No measuring necessary at this point.
5. Remove rotten portion of post.
6. Clean out post hole to provide a level, compacted base for the pre-cast concrete pad. Sakrete or ready mix concrete can also be used for post base.
7. Install pad and measure the Perma-Column for exact clearance needed. *Note: Perma-Column length may vary.
8. Mark existing post and cut to desired clearance for Perma-Column installation.
9. Install and position Perma-Column.
10. Install 1/4" x 3" wood lags. Drill and install (2) 1/2" bolts.
11. Reattach siding and skirt board.
